NASA Electronic Parts and Packaging (NEPP) Program

NEPP Task: "Screening Techniques for Ceramic Capacitors with
Microcracks"

Susceptibility to Cracking of Different Lots of CDR35 Capacitors

Alexander Teverovsky

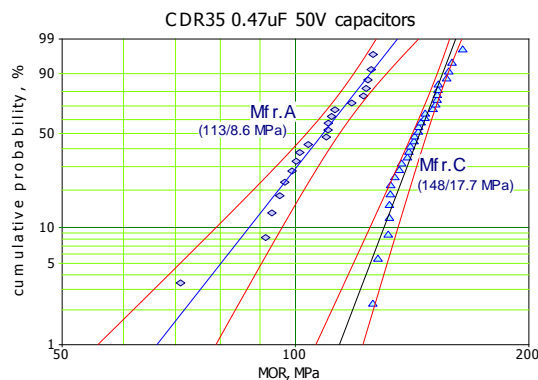
Distributions of values of the flexural strength (modulus of rupture, MOR) for Mfr.A and Mfr.C capacitors are shown in Weibull coordinates in Fig.7. The characteristic MOR values are 113 MPa for Mfr.A and 148 MPa Mfr.C capacitors. The shape parameters are 8.6 and 17.7 respectively for group A and C. At a confidence level of 90% the distributions are different and suggest a higher tensile strength for capacitors from Mfr.C.

Figure 7. Distributions of the flexural strength (MOR) for Mfr.A and Mfr.C capacitors. Red lines indicate 90% confidence bounds.

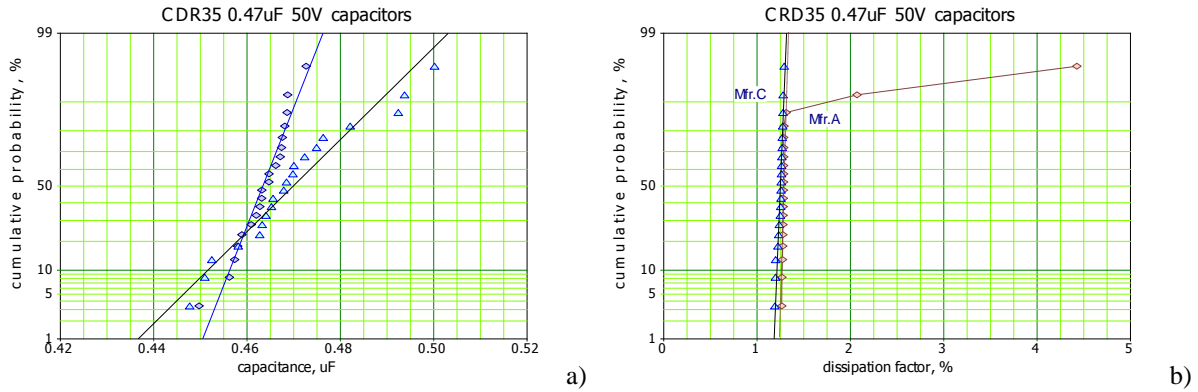
Measurements of AC characteristics after TSD350 did not reveal any significant variations in capacitance, but two samples from Mfr.A (SN1 and SN5) had substantially increased dissipation factors (see Fig.12). This concurs with the results reported in [5], where capacitors with delaminations had increased DF , but normal capacitance values.

Figure 12. Distributions of capacitance (a) and dissipation factors (b) after TSD350.

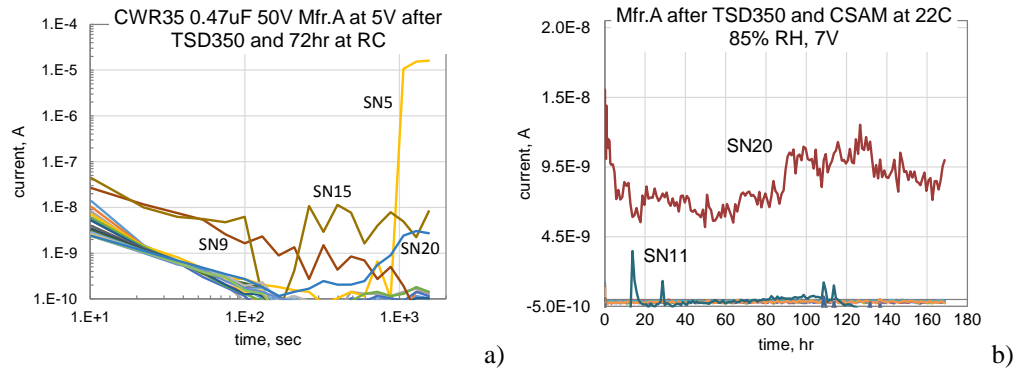
Then the parts were installed in humidity chamber and the testing continued at 7 V, 22 °C, and 85% RH for 170 hr. Leakage currents in capacitors from Mfr.C remained below 1 nA. However, two samples, SN20 and SN11, from Mfr.A had relatively minor, below ~ 10 nA, but noticeable current spikes (see Fig. 13b).

Figure 13. Variations of leakage currents in Mfr.A capacitors at room conditions and 5 V after TSD350 and 3 days of storage at room conditions (a) and at room temperature, but humidity increased to 85% (b).

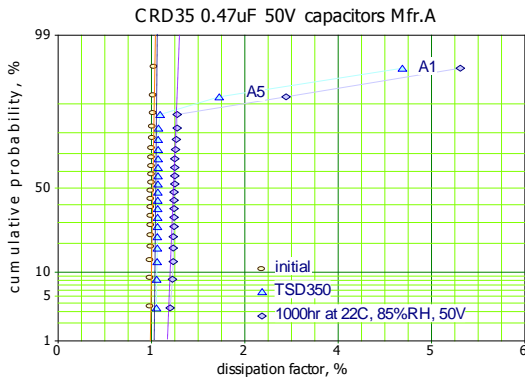
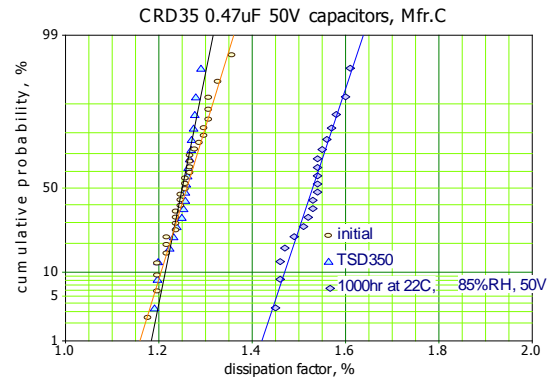
Distributions of AC characteristics measured after 1000 hours of testing in humidity chamber in comparison with initial characteristics and characteristics measured after TSD350 are shown in Fig.15. Except for two samples from Mfr.A, AC characteristics of the parts had no significant variations. Results show that DF is a more sensitive parameter to the presence of defects compared with C and IR .

Figure 15. Distributions of capacitance (a, b) and dissipation factors (c, d) for capacitors from Mfr.A (a, c) and Mfr.C (b, d) measured initially, after TSD350, and after 1000 hours of testing at 85% RH, 50V.

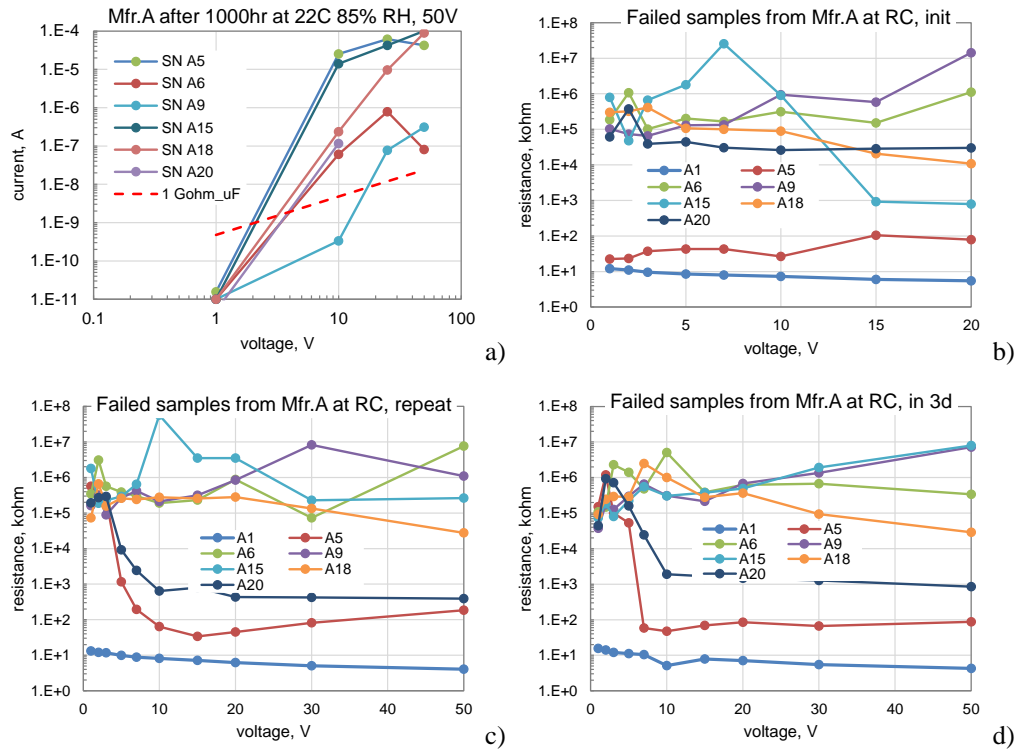
Variations of leakage currents with voltage in failed capacitors that were measured in the humidity chamber immediately after the end of testing at 50 V and depolarization at 0 V for 1000 sec are shown in Fig. 17a. Leakage currents at 1 V were negligibly small in all samples indicating recovery of resistance after the voltage is removed. At voltages more than 10 V, samples SN6 and SN9 exceeded maximum leakage currents by less than an order of magnitude, and can be considered marginal failures. The rest of the failed samples at 50 V had high leakage currents that were limited by resistors connected in series with each part. For this reason in the following testing resistance, R , instead of leakage current was calculated based on measured voltage drops across the current sense resistors (10k).

Approximately three hours after removal from humidity chamber, the parts were tested at room conditions at different voltages up to 20 V (see Fig. 17b). Only two samples, SN1 and SN5) had resistances in the kilo-ohm range, while all others had $R > 1$ Mohm. In some samples resistance did not change substantially with voltage, whereas in others R was unstable, increasing or decreasing with voltage, indicating that voltage application can change conductivity in the cracks with time under bias. This was also confirmed by repeat measurements made when voltage increased up to 50 V (Fig. 17c). Two samples, SN5 and SN20 increased R by approximately four orders of magnitude when measured at low voltages, ≤ 5 V, but decreased to 0.3 – 0.5 Mohm at 50 V. This is likely due to the conductivity increasing with time under bias. Measurements after 3 days of storage at room conditions did not change R -V characteristics substantially (compare Fig.17d and 17c).

Figure 17. Variations of leakage currents and resistance with voltage for failed capacitors from Mfr.A.

- a) Measurements of leakage currents inside the humidity chamber immediately after testing and depolarization for 1000 sec.
- b) Variations of resistance with voltage up to 20 V after removal from the chamber.
- c) Repeat R -V characteristics up to 50 V.
- d) Final R -V characteristics after 3 days of storage at room conditions.

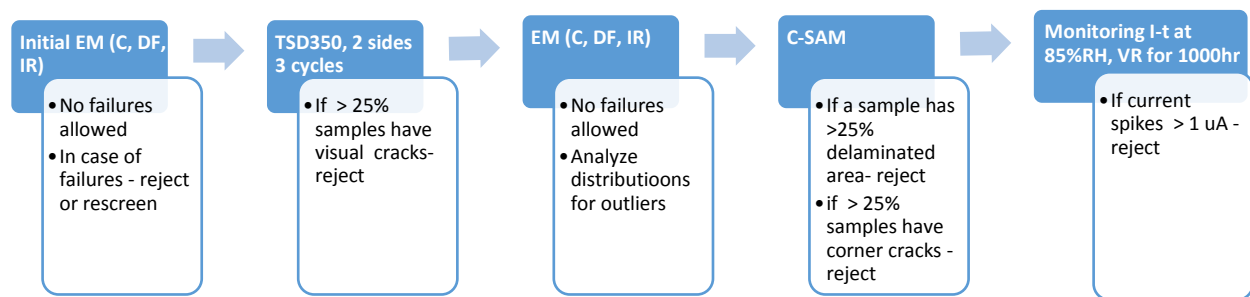
Figure 26. A test flow for the resistance to manual soldering testing.

Unfortunately, no single test can provide reliable information regarding the susceptibility of a lot of capacitors to cracking, and establishing criteria for a lot acceptance is extremely difficult. However, some tests have been shown to have a greater sensitivity than the others. These include TSD350, acoustic microscopy, analysis of distributions of MOR, DF and IR, and monitoring of leakage currents in humidity chamber. A combination of these tests can be used to select the most robust to manual soldering capacitors and mitigate risks of failure. An example of the test flow to assess the resistance of capacitors to manual soldering stresses is shown in Fig. 26. This test flow can be tailored for projects based on specific conditions and the level of risk acceptance. For example, TSD350 might be replaced with actual manual soldering of capacitors on a test board.
